SUBJECT: Operational Report - Lessons Learned, Headquarters, 520th
Transportation Battalion, Period Ending 30 April 1970

SUBJECT: Operational Report - Lessons Learned 520th Transportation Battalion
(AM&S) (GS) Period Ending 30 April 1970, RCS CSFOR-65 (R2)

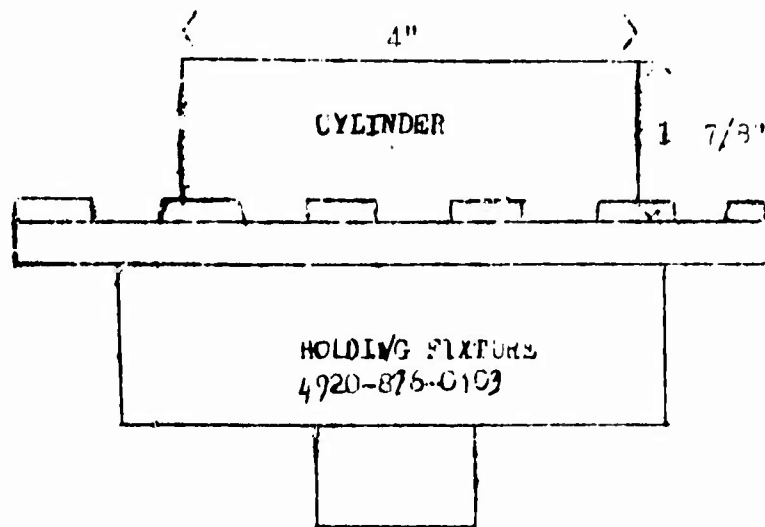
INCL-2

(a) Observation: To assist in the assembly and grease packing of the UH-1 main driveshaft, a modification can be added to the holding fixture (FSN 4920-876-0131). It is placed on top of the holding fixture as shown in the inclosed diagram (Inclosure 2).

(b) Evaluation: The modification is made of aluminum and consists of a cylinder 17/8" high and 4" in diameter. The fixture stabilizes the driveshaft during assembly and also aids in grease retention as it prevents the driveshaft from sliding down into the coupling. During periods of storage the cylinder is left in place to maintain the grease wall of .020-.030 inches above the top of the splines.

UH 1 DRIVESHAFT MODIFICATION

(c) Recommendation: That the described fixture be utilized to stabilize the driveshaft during assembly, and in maintaining the grease wall as required in accordance with TM 55-1520-210-35-2 and TM 55-1520-210-20.
